Manhole Inspection Summary

Manhole # S21WW1012MH

Location Address: **5000 FALLS RD** Cross Street: **CROSS KEYS RD**

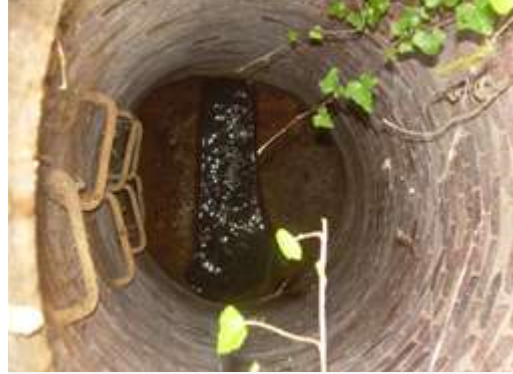
Top View

Evidence of surcharge - Bench debris.

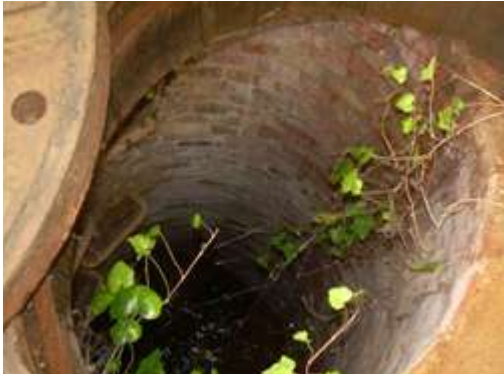
Defect

Frame offset. Corbel deterioration root intursion and infiltration.

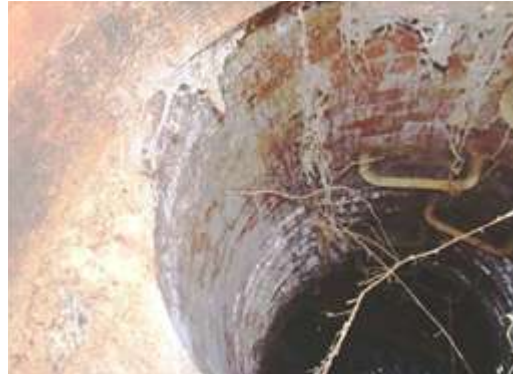
Defect

Frame leaks. Frame offset. Corbel deterioration, root intrusion and infiltration.

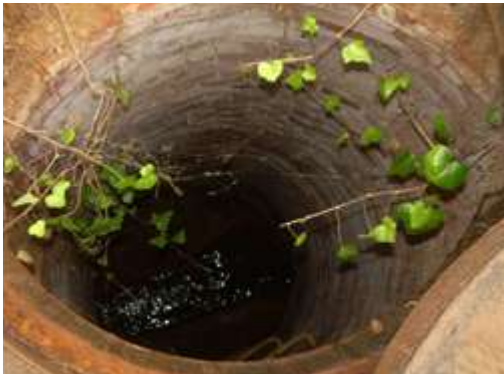
Defect

Frame offset. Corbel and Barrel infiltration.

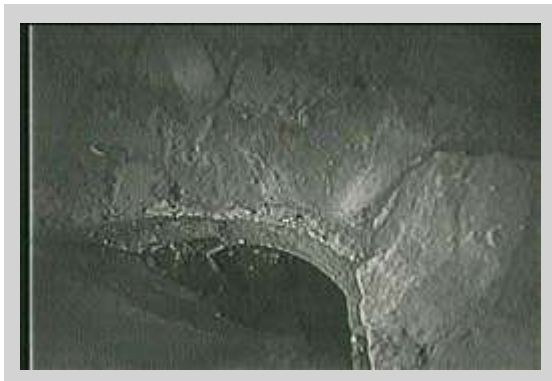
12 in. Circular Gravity Sewer Pipe In @ 7 O'Clock

Infiltration: **Evidence** Pipe Seal Cond: **Cracked**
